**Randolph County Courthouse Building
110 South Main Street
Huntsville, Missouri
July 14, 2007**

INVESTIGATIVE ENGINEERING REPORT

General Structural Building Condition Investigation

**Randolph County Commission
110 S. Main Street
Huntsville, Missouri 65259**

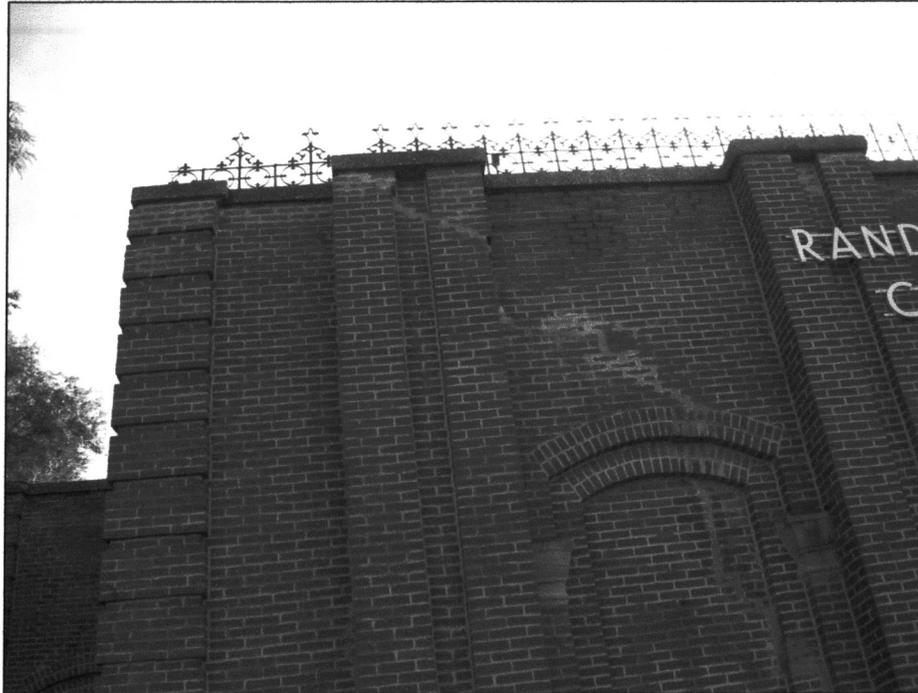
Photo #1

As can be seen in photo #1 there was a large crack in the brick that starts at the foundation and travels to the top of the wall on the northwest corner of the main building that had been filled with mortar. Photos #2 and #3 show how this corner has moved relative to the cap at the top of the wall. Photos #4 through #7 show general deterioration of patches made to various stone elements along the west and southwestern perimeter of the main building. Photos #8 and #9 show a rod and channel element that have sunk into the brick wall in a very isolated area on the south elevation of the main building. Photos #10 and #11 show brick above openings on the southward elevation that have been replaced as is evident by the mismatched running bond. Photo #12 shows a crack that has been patched under a window along the southwest corner of the main building. Photos #13 and #14 show vegetation that has grown at the corner of the south vault and the southeast addition to the main structure. Photo #15 shows how water sits on the south vault roof due to the vegetation growing in the gutter system.

It is our opinion that most of the issues that were found are currently cosmetic. However, there were two items that we feel will need to be addressed in the near future, first being the large crack in the brick at the northwest corner of the main building and second, the rod and plate/channel connections that have over time sank into the brick.

Our concern with the large crack in the brick at the northwest corner of the main building is that the bricks on the interior of the building appear to show deterioration due to water infiltration. The brick mortar at the interior portion of the wall in the vicinity of the crack appears to be in a very delicate state, and thus making the wall susceptible to losing bricks to the interior of the building. Also, the inside row of brick is now carrying some of the roof load at this corner of the building, which will also increase the likelihood of the wall shedding bricks to the inside of the building.

Once the large crack and the rod and plate connections are repaired, we believe that the building should perform structurally as any building of this age and type. However, the building does need maintenance in the near future to prevent future issues caused by water infiltration. We recommend that once the water infiltration issues are repaired and the

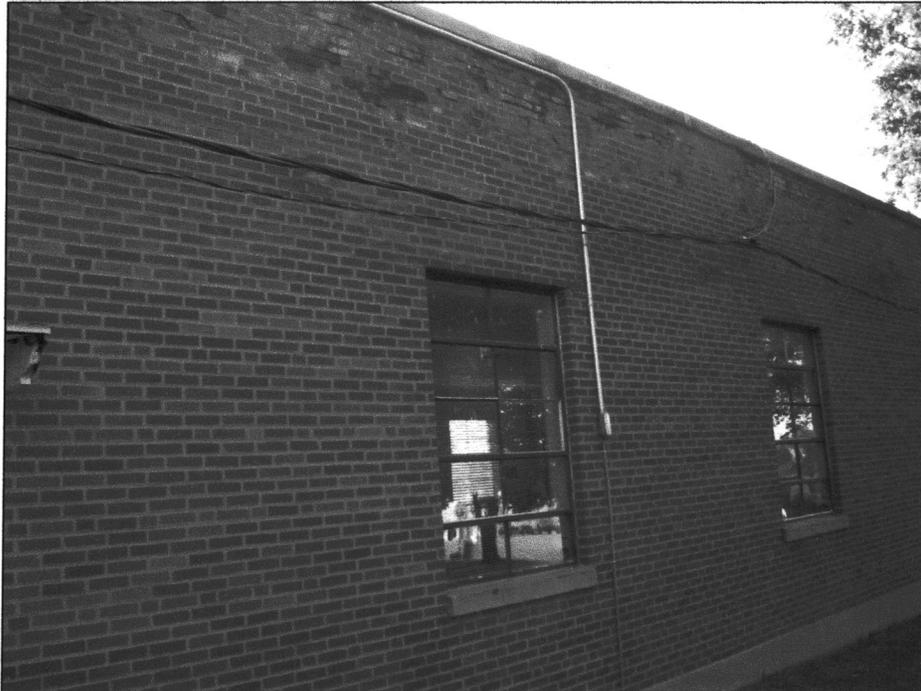
The next few photos are of the southeast addition to the main building. Photo #16 and #17 show some delaminated bricks near the top of the wall on the west face of the southeast addition to the main structure. The east elevation of this southeast addition is shown in photo #18, and a crack that has occurred both above and below one of the windows on this elevation is shown in photo #19.

The general deterioration of patches to the stone features, delamination of bricks, isolated cracks, and expansion joint issues all will require attention in the next year or two. The main concern is that each will allow water to get inside of the wall cavity and with freeze and thaw cycles will eventually cause the wall structure to deteriorate. The deteriorated patches on the stone should be removed and replaced properly, the delaminated bricks should be replaced, and the expansion joints should be reinstalled properly. Also, the building should be tuck pointed and sealed at that time and a regular maintenance program should be implemented. Lastly, any aesthetic issues as with the brick patches that were installed without fingerings in the bricks can be addressed at that time.

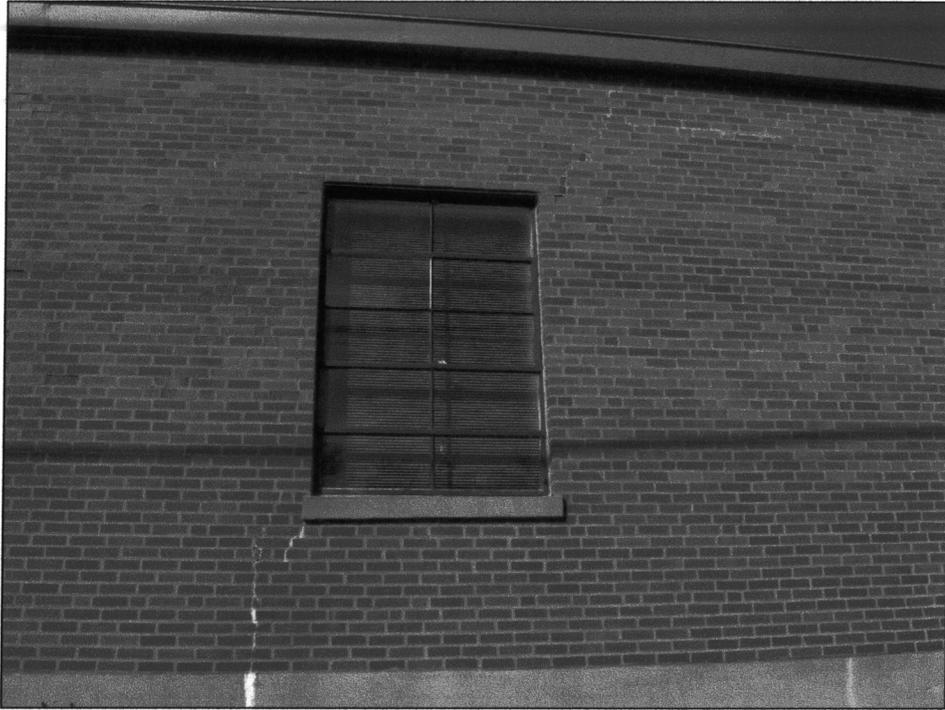
Photo #19

The cracks should be addressed one by one. For example the crack above and below the window in the east wall of the southeast addition to the main building is caused by the long stretch of brick not having an expansion joint, which is typically installed every 20 to 30 feet in one continuous wall. Since this crack will continue to operate as an expansion joint, opening and closing, this crack can be sealed with a silicone sealant that will expand and contract with the crack movement. The crack where the brick is placed on top of the stone base of the main building at the west side of the northeast addition will need to be disassembled and properly rebuilt to allow for the added structure to move independently of the main building. The problem being that the addition is trying to settle, which is typical for all newer structures, and the main building has mainly finished settling.

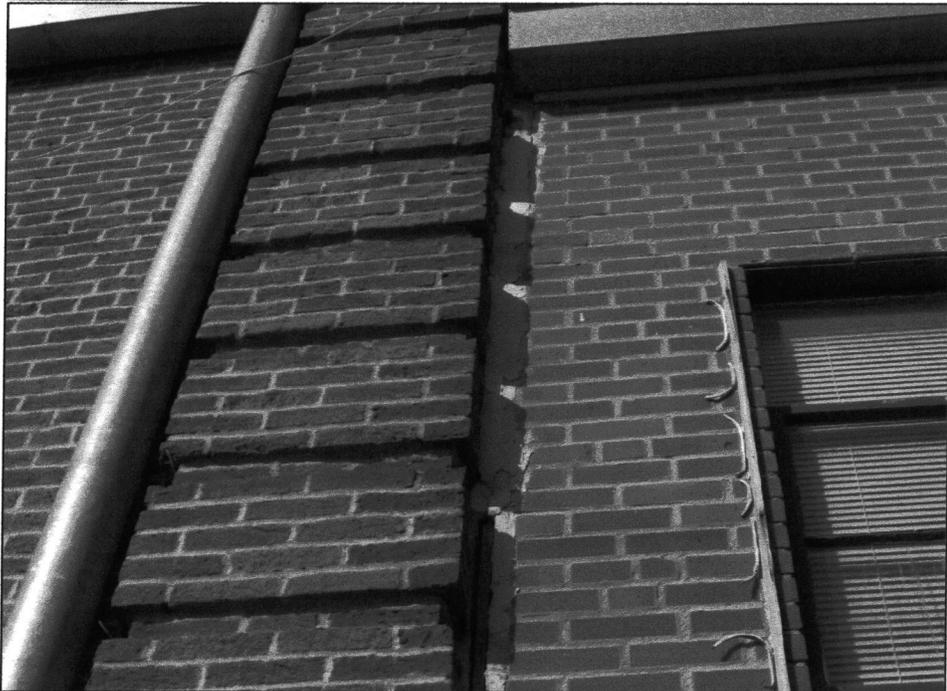
Photo #20

The following are issues found at the perimeter of the northeast addition to the main structure. As can be seen by photo #20, the expansion joint between the main building and the northeast addition is quite large and is no longer functioning as originally intended. Photo #21 shows a crack that has developed under a northward facing window, and photo #22 shows the west side of the addition where it connects to the main building. As can be seen by photo #22, the brick from the addition was placed on top of the stone base of the main structure, and a crack has occurred at this location.

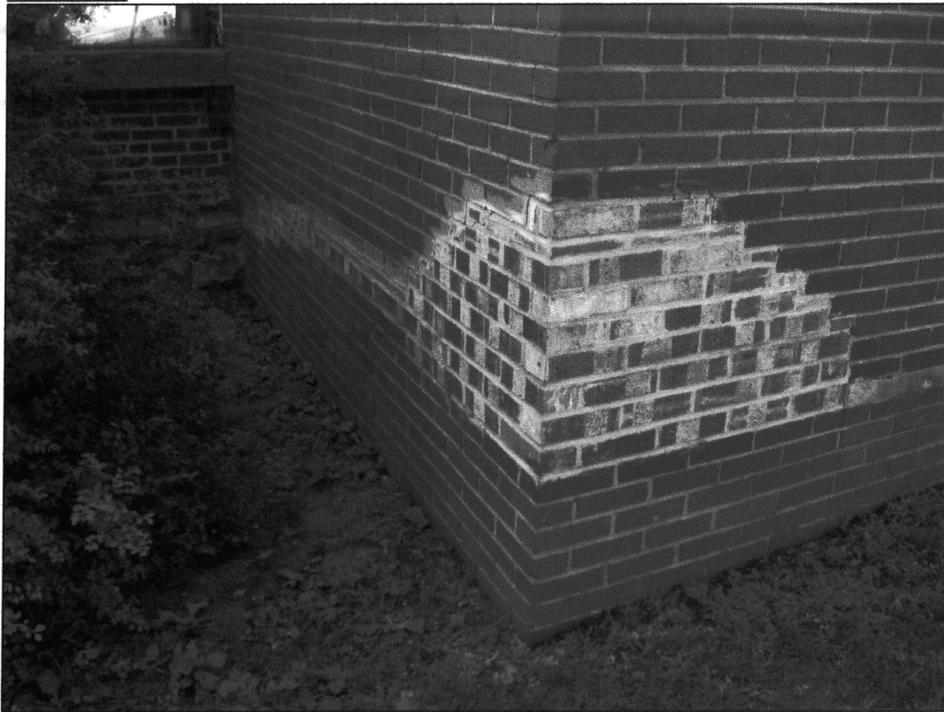
Photo #23

The following are issues found at the north vault structure and the northwest addition to the main building. As can be seen by photo #23, there has been a repair on the northeast corner of the vault, and it has a bit of an outward bulge. Photo #24 shows how the north vault is tied into the brick on the main building. Photo #25 shows a deteriorated expansion joint from the main building to the northwest addition.

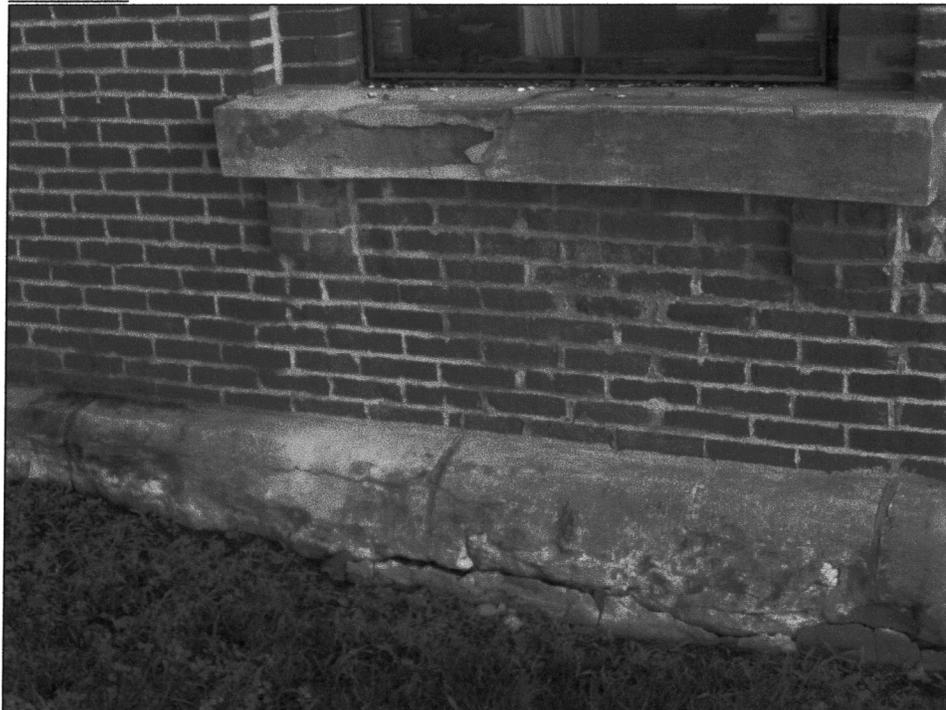
The remaining exterior perimeter photos show the north face of the main structure. Photo #26 again shows some patches along the stone base that have deteriorated. Photo #27 again shows some brick that has been patched as is evident by the mismatched running bond. Photo #28 shows a well installed rod and plate at the roof level, while photo #29 shows a poorly installed rod and plate on the northwest corner at the roof level.

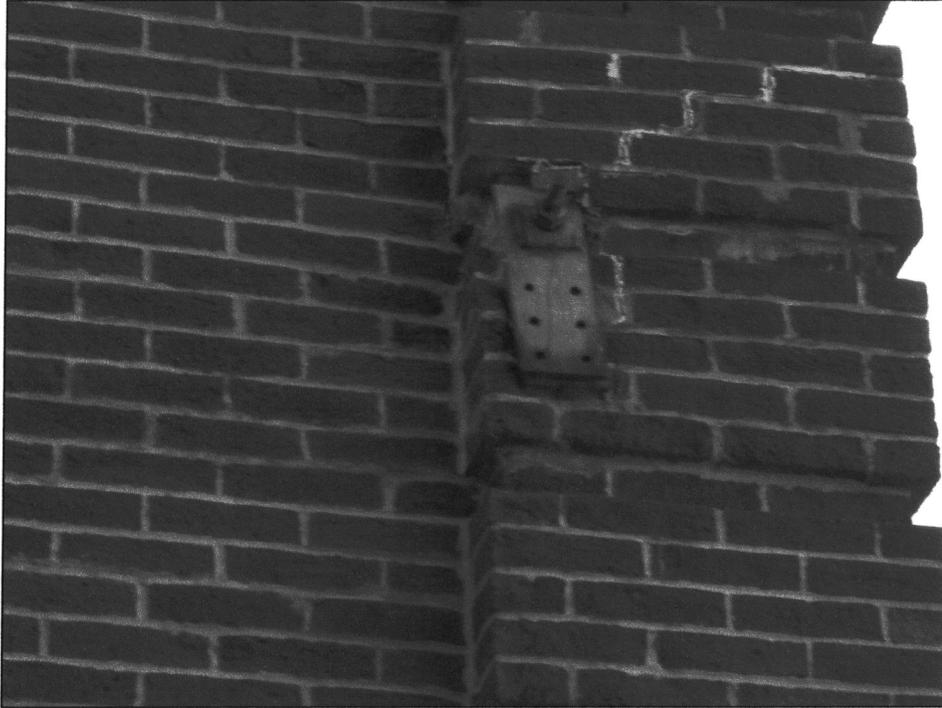
Photo #29

Our concern with the rod and plate connections at the roof level on the exterior of the main building is that the rod and plate may not be providing the support to the wall as originally intended. We believe that this rod connection was installed to provide support for the end walls when the second story of the main building burnt. We recommend that the brick behind these existing connections be repaired and that a new larger bearing plate be installed that will distribute the load over a larger area and prevent the likelihood of the bricks to sink into the wall in a localized area as is now the case.
