**Randolph County Courthouse Building
110 South Main Street
Huntsville, Missouri
July 14, 2007**

INVESTIGATIVE ENGINEERING REPORT

General Structural Building Condition Investigation

**Randolph County Commission
110 S. Main Street
Huntsville, Missouri 65259**

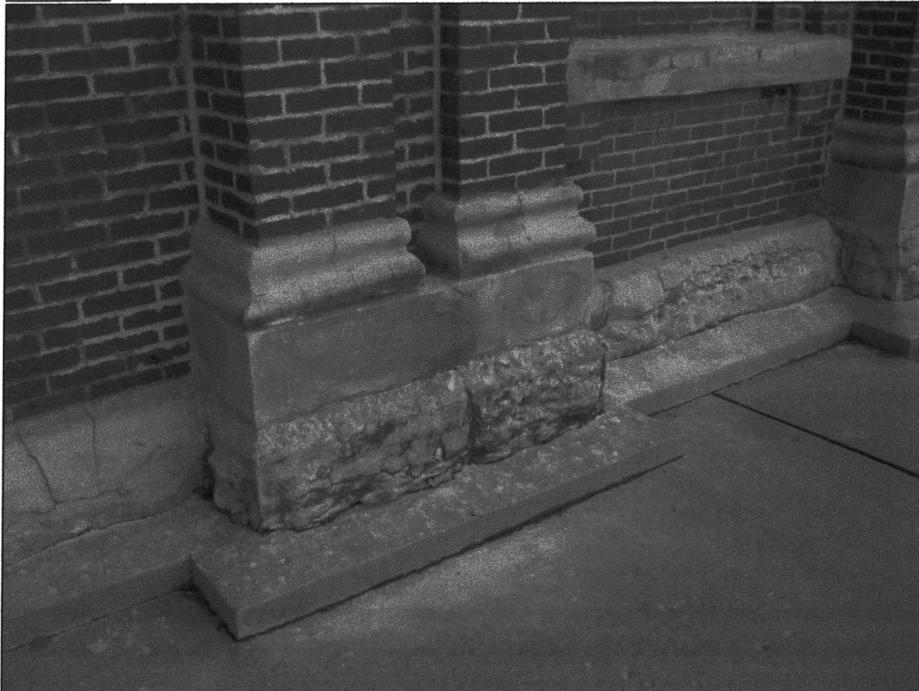
Photo #4

As can be seen in photo #1 there was a large crack in the brick that starts at the foundation and travels to the top of the wall on the northwest corner of the main building that had been filled with mortar. Photos #2 and #3 show how this corner has moved relative to the cap at the top of the wall. Photos #4 through #7 show general deterioration of patches made to various stone elements along the west and southwestern perimeter of the main building. Photos #8 and #9 show a rod and channel element that have sunk into the brick wall in a very isolated area on the south elevation of the main building. Photos #10 and #11 show brick above openings on the southward elevation that have been replaced as is evident by the mismatched running bond. Photo #12 shows a crack that has been patched under a window along the southwest corner of the main building. Photos #13 and #14 show vegetation that has grown at the corner of the south vault and the southeast addition to the main structure. Photo #15 shows how water sits on the south vault roof due to the vegetation growing in the gutter system.

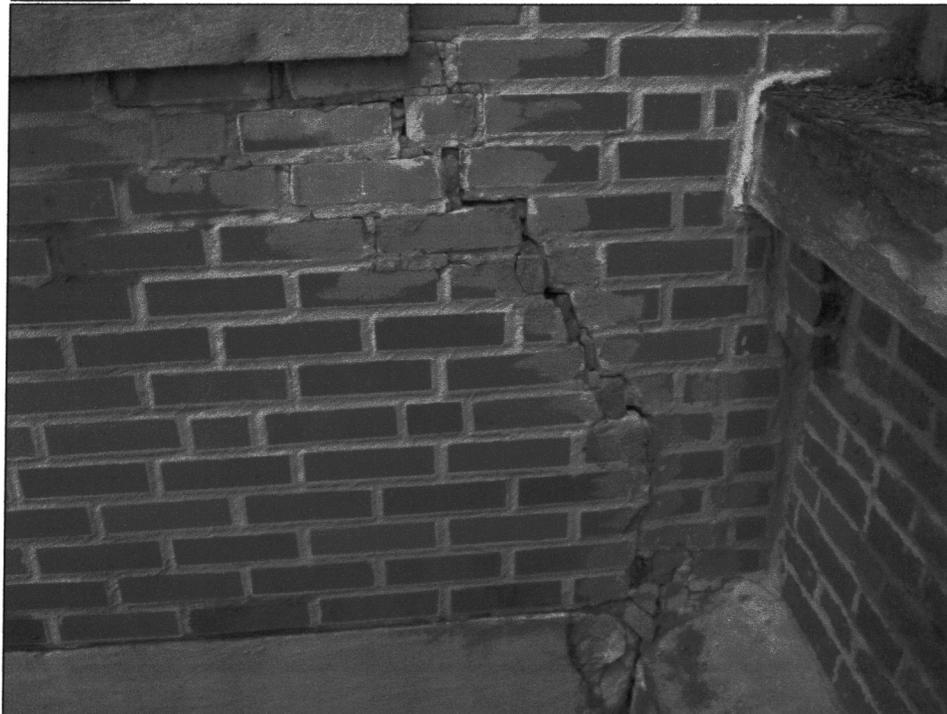
Photo #23

The following are issues found at the north vault structure and the northwest addition to the main building. As can be seen by photo #23, there has been a repair on the northeast corner of the vault, and it has a bit of an outward bulge. Photo #24 shows how the north vault is tied into the brick on the main building. Photo #25 shows a deteriorated expansion joint from the main building to the northwest addition.
